August 1, 2025

Re: Structural Assessment of Buildings for Fiber loop access

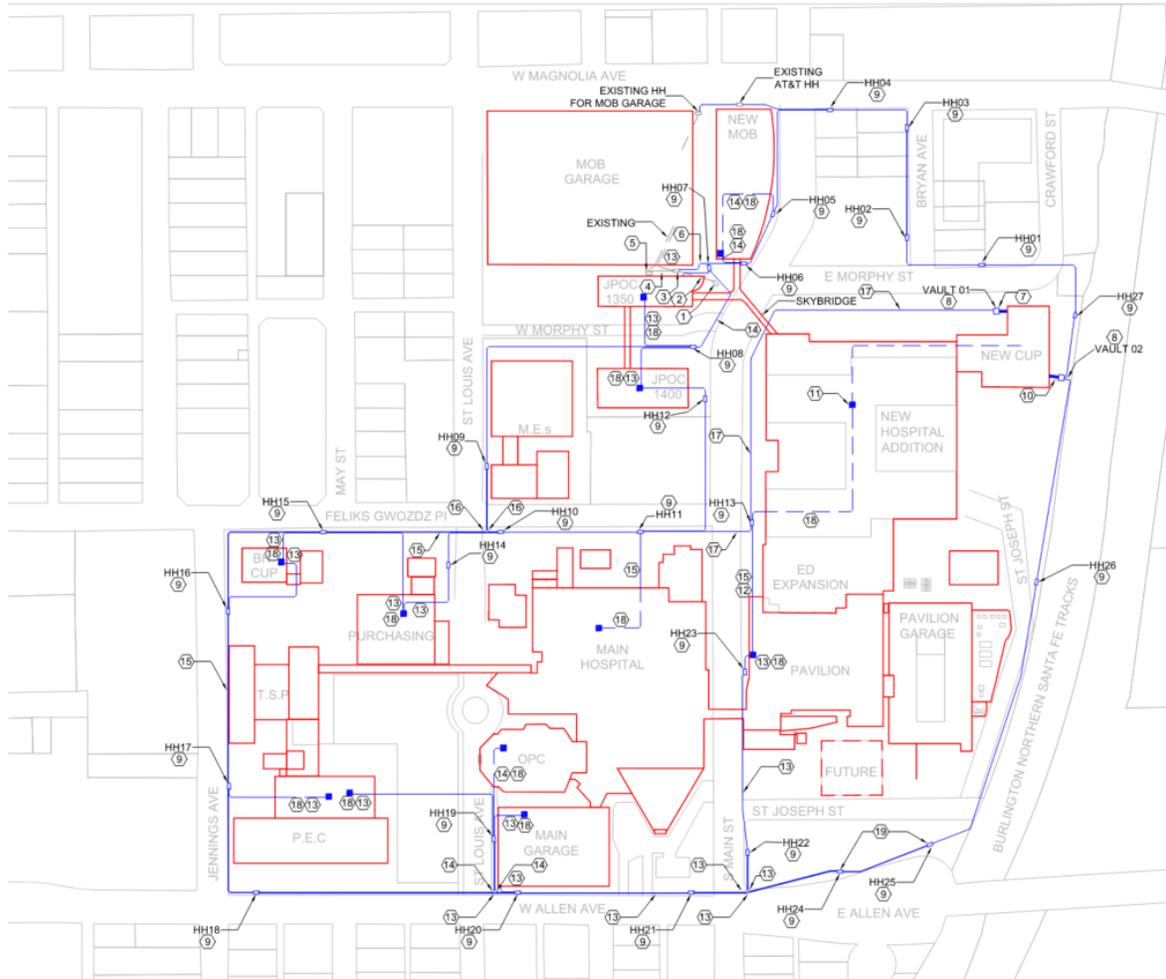
Figure 1 - Planned Fiber Loop Site Plan

During the site walk it was discussed that the fiber needs to enter JPOC 1350 at two locations for redundancy. Figure 1 shows that the plan routes have one access from the north side of the building and a second access would be from the south side of the building. These two routes would be placed under the buildings foundation and then core up to where needed inside the building.

During the site walk it was discussed that the fiber needs to enter JPOC 1350 at two locations for redundancy. Figure 1 shows that the plan routes have one access from the north side of the building and a second access would be from the east side of the building. These two routes would be placed under the buildings foundation and then core up to where needed inside the building. Also discussed during the site walk was to exit the ground outside the building and then core through the east wall near the fire riser room. This was discussed as an alternative since we did not have any information about the buildings foundation at that time.

The main garage has a planned fiber loop location is just off of ST LOUIS AVE and there is already an existing access point just outside of the garage. This can be seen in Figure 1. This was the only access discussed on site. The plan in Figure 1 does show an access line from the south into the Main Garage. This access should be possible to install with the main garages foundation system.

Due to the extra steps, phases and being unable to place all the fiber below grade BHB proposes a different option. The recommended route to get into the building would be to take the cables to a perimeter wall and then up and enter the building above grade.

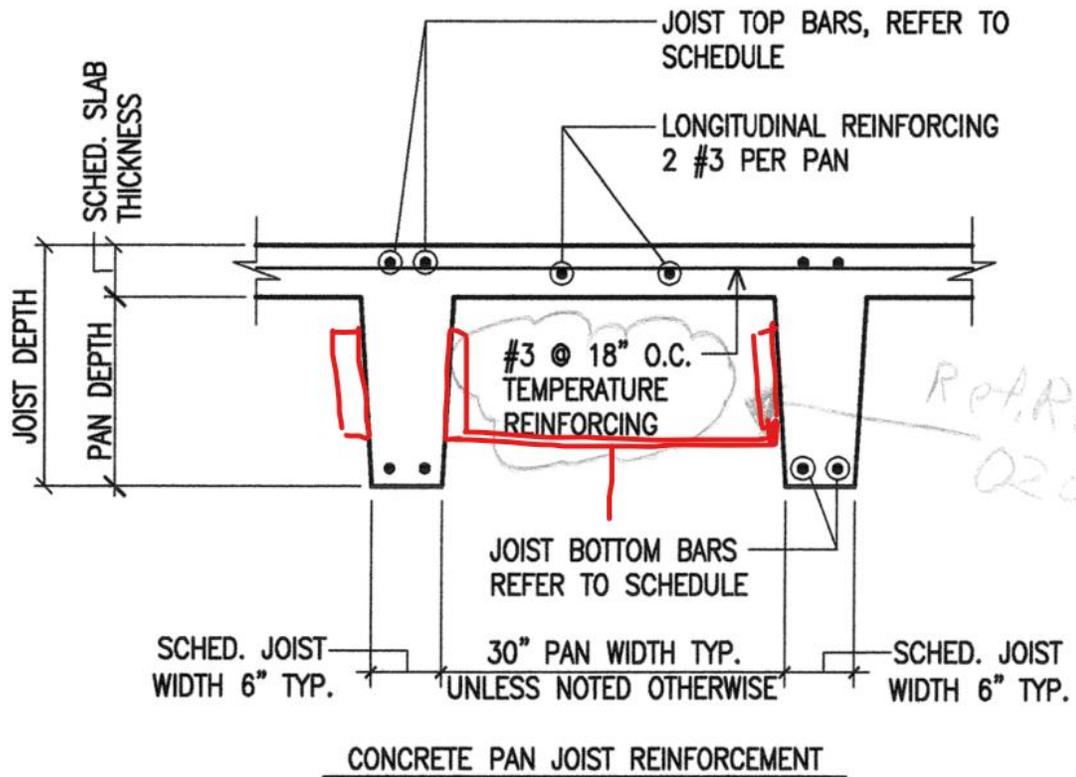
The basement wall on the north side of the building is cast in place concrete. The wall at this location is 1'-6" thick with #6 at 8" O.C.E.F. and #5 @ 12" O.C.E.F.. The first floor is a cast in place pan joist system. Hangers to

support the fiber cable would need to be hung or supported off the face of the joist. See the red marks in Figure 3.

During the site investigation the two paths shown on Figure 1 were discussed. Both access points into the building were planning to originate from Feliks Gwozdz PI and then head south towards the purchasing building. Which one would then enter on the north side of the building and the other on the east face. The access point on the north wall has some hurdles to over come. This side is a loading dock. The pavement slopes up towards the building but the buildings floor level is over 4'-0" from that grade. To run the fiber along this path paving would need to be trenched to allow installation, however at the building the fiber would need to 90 degree and run up the face of the wall. There is another hurdle the path shown on Figure 1 where the north side enters the building that area has a landing and is recessed from the loading dock area of the building located more to the west. This would require another 90 degree turn or would need to continue up the building more before 90 degree turning to core and enter the building through the north wall. See Figure 3 which is from Google Earth to hopefully assist as a visual aid.

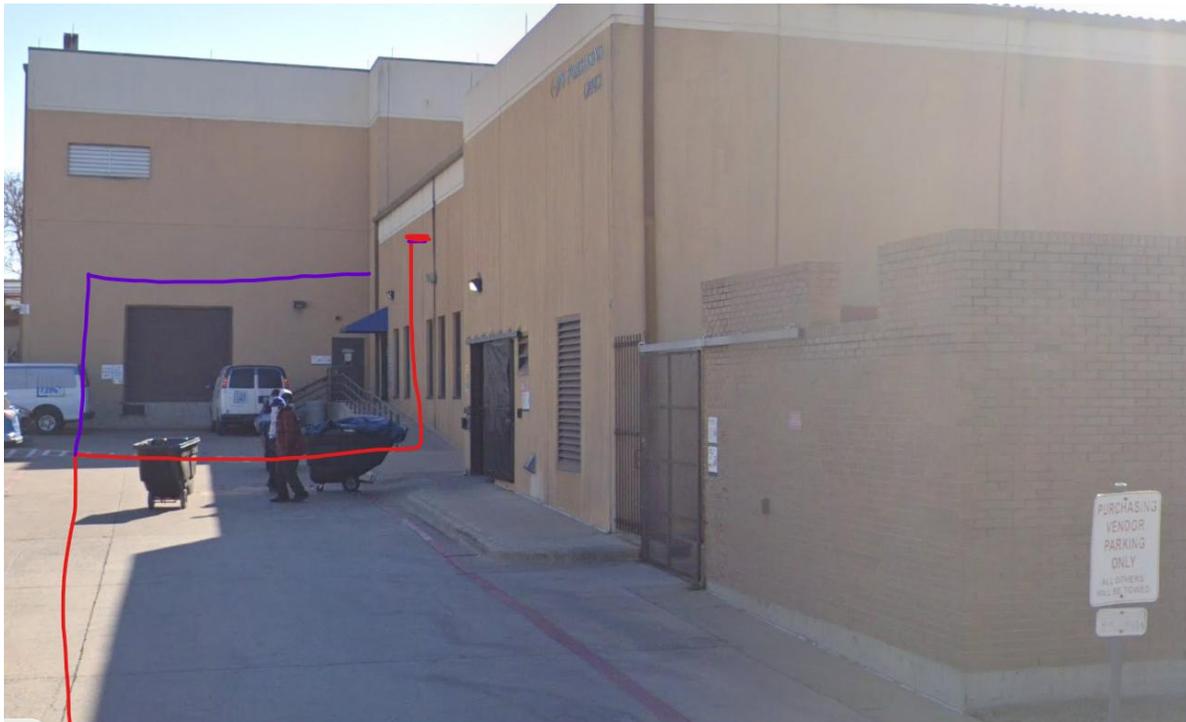
The second access that is also from the north would need to enter the building on the east face. See Figure 5 for the following two options. The first path is marked in red which was discussed on site. The fiber would

come south and then go west up the building face before coring and entering through the wall. This would come south requiring demolition of the paving and then part of the ADA access ramp. The second option which is shown in purple. Would be to demolition the paving and then run up the building face on the north side further south and then 90 degree and run along the north wall and then core and enter the east facing building wall running right to the IDF room.

BHB's thoughts based on the information only from the site walk the best access would be from FLIKS GWOZDZ PL coming down the east face of the building below grade and then up the face of the building and shooting back west to minimize turns to the cable and possible additional work to the structure. The same approach can be applied for the second access needed here and would occur on the north side of purchasing. The cable can be below grade until it hits the building then move up the structure and have a straight shot to the IDF closet. The fiber in either of the options once entering the building would be suspended and supported from the roof structure. BHB was able to see some of the roof structure at one location in purchasing. At this location the roof was steel joists with metal deck. The final fiber path would need to be known for an analysis of the roof structure to be done to see if the joists can support the load without needing to be reinforced. Also, if no drawings are provided with information field measurements will need to be done to get and estimate, however this will make the analysis fall more conservative.
